Type B Accident
Investigation Board Report
on the July 7, 1997
Industrial Accident
at the
Knolls Atomic Power Laboratory-
Windsor Site

Schenectady Naval Reactors Office
U. S. Department of Energy

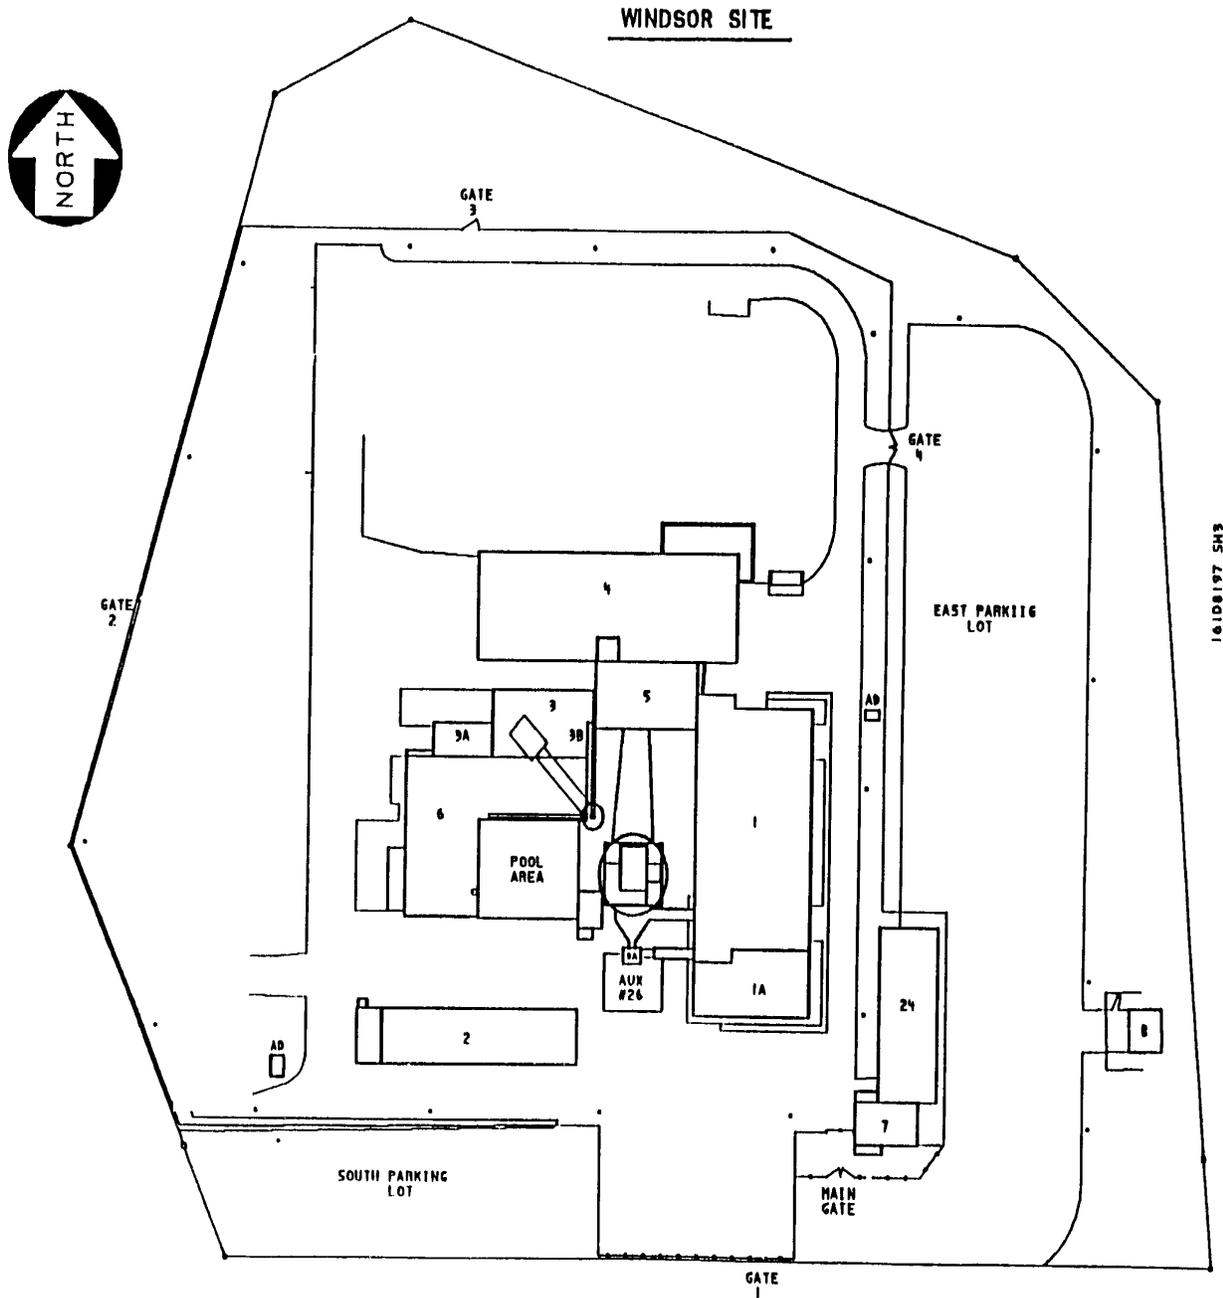
Figure 1 - Site map

On Monday, July 7, 1997, at approximately 10:47 a. m., an asbestos abatement subcontractor laborer working at the Knolls Atomic Power Laboratory-Windsor Site stepped on and fell backward through an unprotected rooftop skylight in the northwest quadrant of Building 5 (see Figure #1). The laborer, who was wearing a full body safety harness, fell approximately 37 feet. The fall was arrested prior to the subject's torso contacting the building floor when his lifeline became entangled with a small diameter nylon rope being used as a control line on the roof to identify areas requiring fall protection. During the fall, the laborer contacted a metal conduit, firemain piping and, according to one witness, a metal handrail before coming to rest approximately one foot above the concrete building floor. The laborer was transported by helicopter to a local hospital, where his injuries were determined not to be life threatening. On July 10, 1997 he was released.
